Reconstruction Building Typology and Major Non-compliance Issues: Post-Earthquake Experience from Dhading

Rajesh Kumar Shrestha^{1*}, Hari Ram Parajuli², Bipul Poudel³

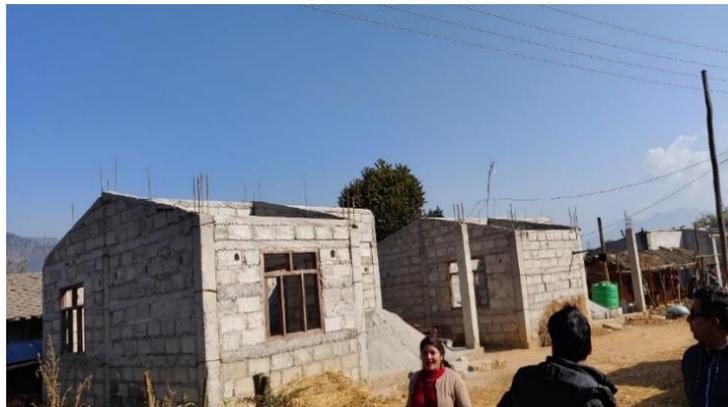
- i) **Corner Column:** In this type of buildings, columns are casted at corners and wall intersections to replace the corner stones of masonry buildings. Size of columns can be variable with sizes 9"x9", 9"x12", 12"x12" with different rebar specifications. These buildings neither meet the criteria of fully load bearing structures nor confined masonry structures. Building with RCC columns and flexible roofing can also be categorized in this type of structure. Generally, RCC column with flexible roofing results when houseowner initially starts to construct RCC building but later installs flexible roofing due to financial problem. The best suggestion for the houseowner from structural point of view is to construct fully confined masonry.

Figure 2. Corner column structure with hollow concrete block

3.	Corner columns instead of single vertical rebar and Building with RCC columns and flexible roofing.	Columns used at different locations of the wall only replace corner stones but do not take gravity loads and act as frame system unless it is connected by beams/slabs.	At first, structural analysis is carried as a load bearing structure and effect of columns is not taken into consideration. Later, rebar required to take tensile stress is compared against the rebars in columns.

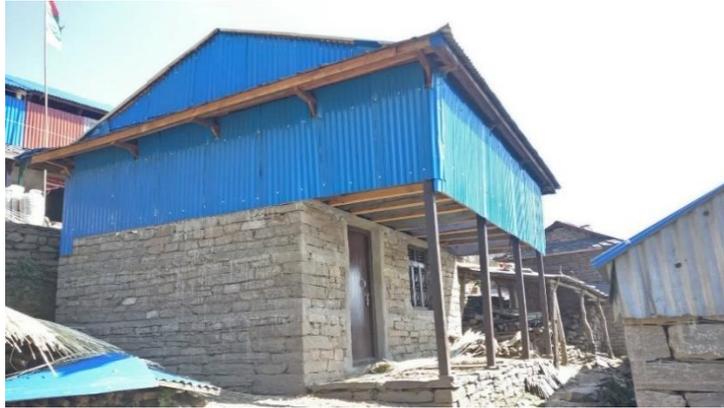
- ii) Hybrid structure: There are two type of hybrid structures, combination of load resisting system (RCC at ground floor and masonry with flexible roofing at first floor) and combination of materials (load bearing walls at ground floor and timber or steel frame with CGI covering at first floor). Second one is found more prevalent in different parts of Dhading. After the Gorkha earthquake, people realized that load must be reduced in upper floor to lower the damage during earthquake. Hybrid structure is the outcome of the realization. NRA has published Hybrid structure manual to support field level staffs for inspection of those houses.

Figure 3. Hybrid structure with CGI covering at first floor

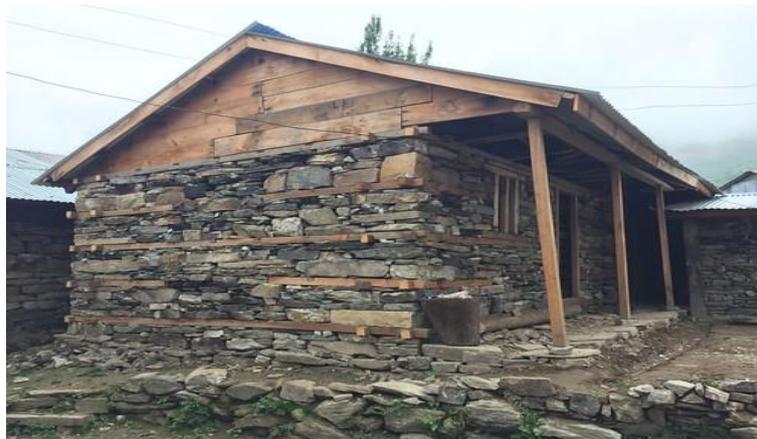
- i) Dry stone masonry: These types of houses are found especially in Northern part of Dhading, Ruby Valley Rural Municipality, where strength of mud mortar is low for construction of mud mortar stone masonry. Also, in these regions, high chances of mud mortar getting damaged by rats provides additional demerit for mud mortar stone masonry. Most of the dry-stone masonry houses are single room where timber is used as horizontal bands and vertical posts.

Figure 4. Dry stone masonry

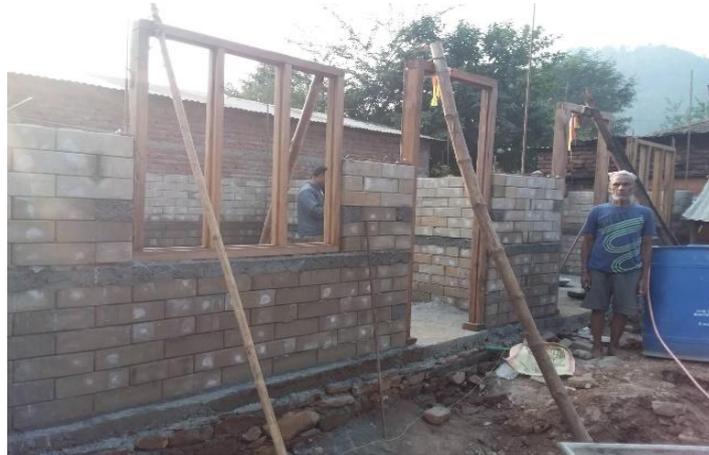
blocks and cement mortar falls in this category. Most of the locally made blocks do not meet the requirements prescribed in design volume catalogue II.

Figure 5. Load bearing interlocking block with cement mortar

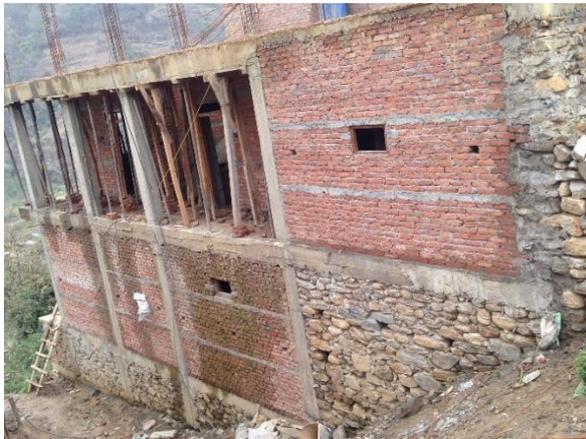
- Column size <12”x12”
- Reinforcement in column < 8 nos. (4-16Ø+4-12Ø)
- Plan and elevation irregularities
- Panel area > 13.5 sq. m.
- Column spacing <2.1m &>4.5 m
- One bay building
- Aspect Ratio >3

Figure 6. RCC building with 9x9 column

S.N.	Major noncompliance issues	Explanation	Solution
1.	RCC frame structure with 10mm rebar in vertical member(column).	As per IS 456, it is not allowed to use reinforcement less than 12 mm in compression member.	The structure is as analyzed framed structure with infill walls not as bare frame structure.

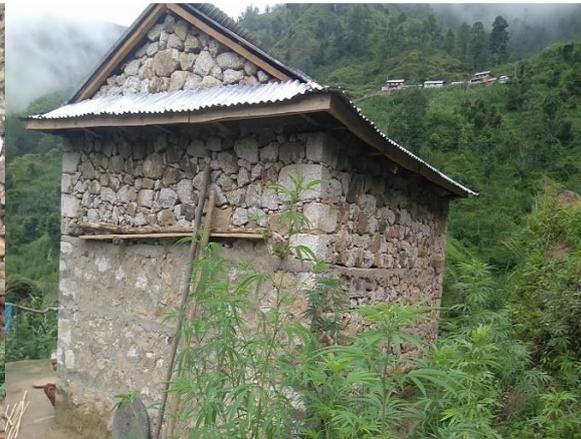
- Absence/ discontinuity of horizontal bands
- Absence of vertical reinforcement
- Absence of roof/gable band

Figure 7. Stone masonry building with no gable wall

5.	Absence of roof /gable band.	The gap between the top horizontal band and rafter/purlin is filled with two or three layers of masonry units with mortar.	The masonry above band has very small height. It is also restrained by vertical elements on sides so failure is unlikely to happen in this zone (Exception)
